# **BATTLESHIP TEXAS (BB-35)**

## **VESSEL INSPECTION AND ASSESSMENT**

Vessel Survey Report No. 2417

Vessel surveyed at:	La Porte, Texas
Dates of survey:	November - December 2010 January 2011
Vessel surveyed:	Battleship TEXAS (BB-35)
Survey commissioned by:	Texas Parks & Wildlife Battleship TEXAS State Historic Site 3523 Independence Parkway South La Porte, Texas 77571
Purpose of survey:	Vessel Condition Survey

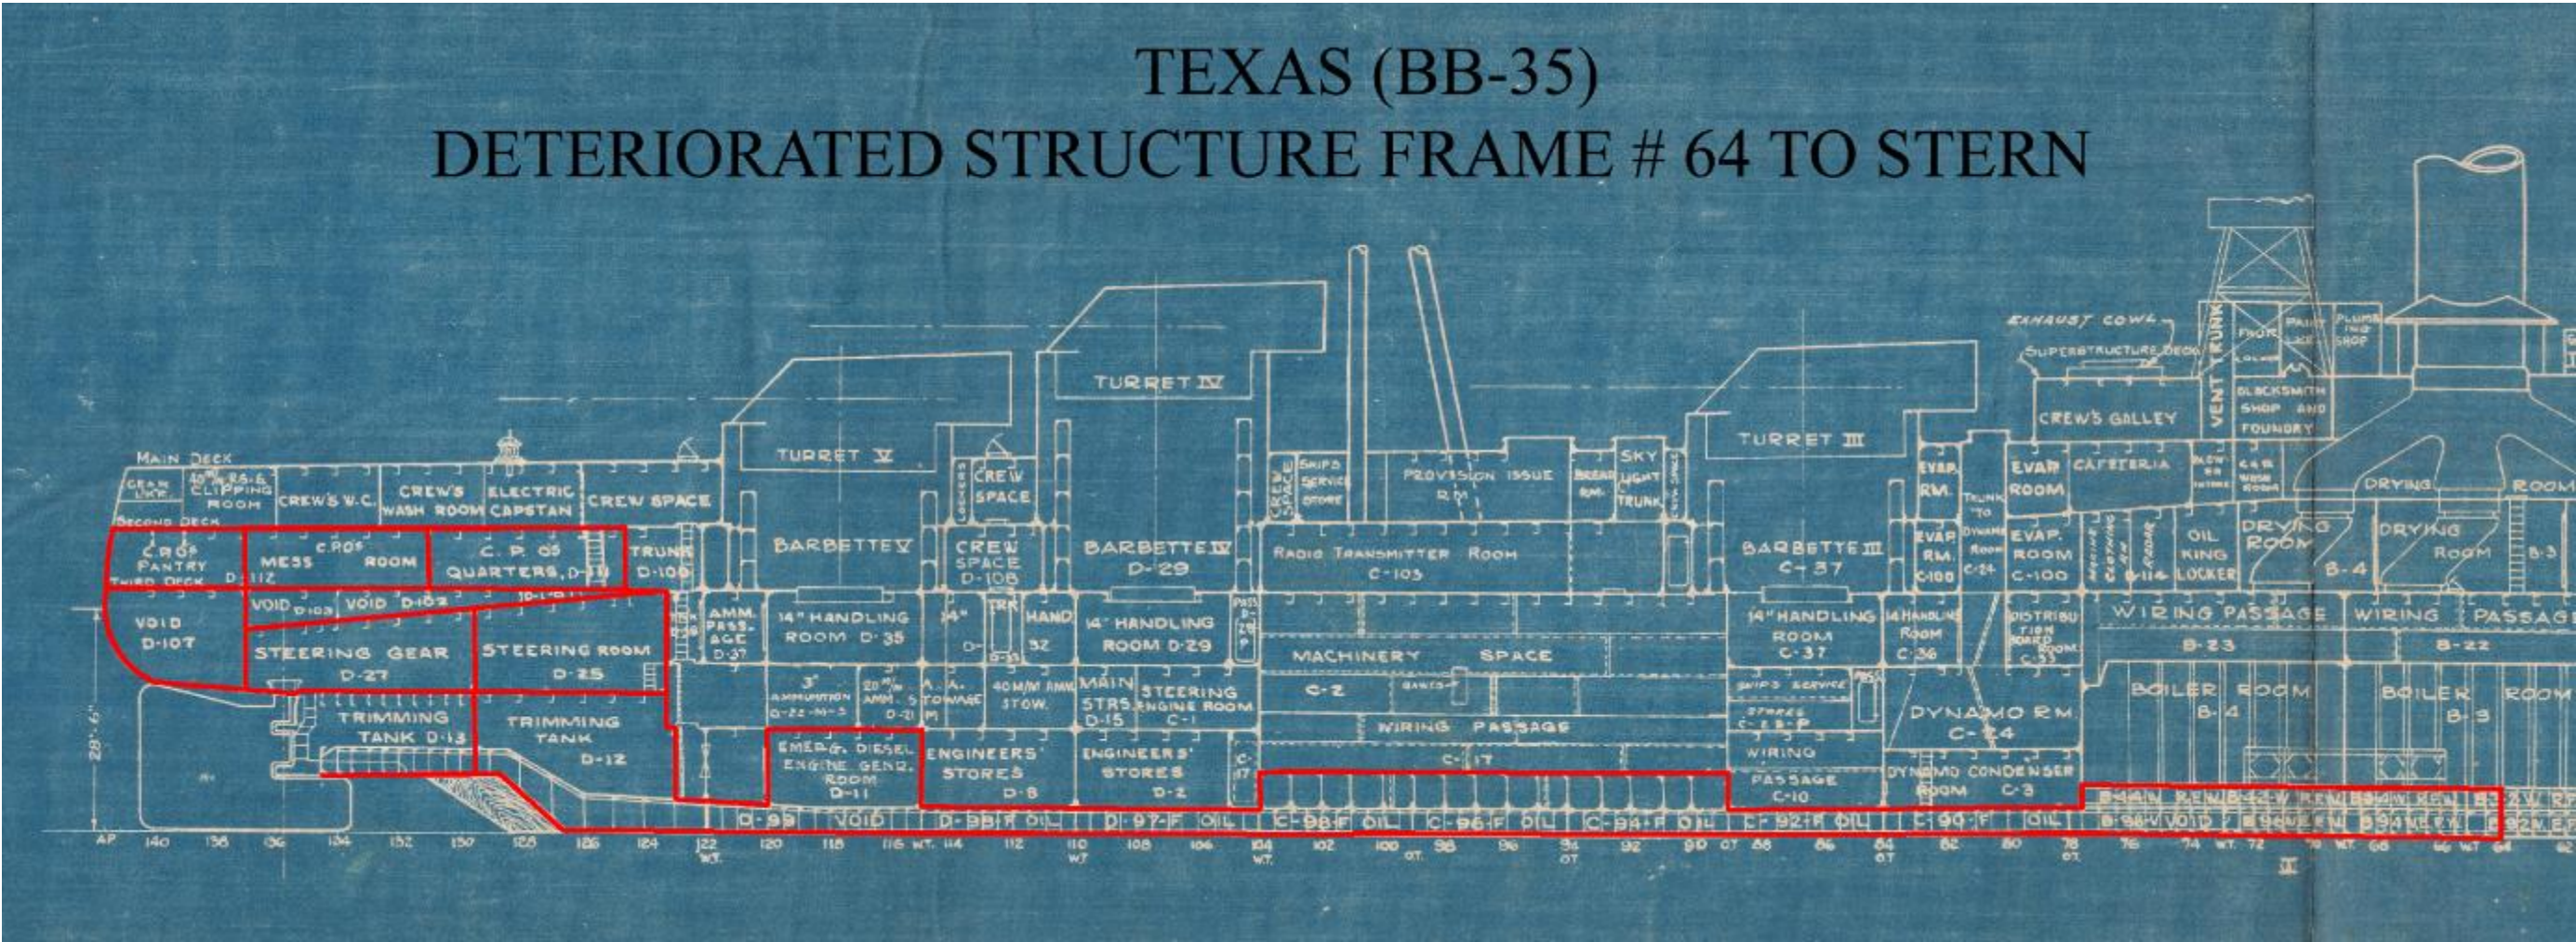
The critical problem areas observed during the inspection, highlighted in Figure 1, are as follows:

Figure 1 Structurally Deficient and Critical Areas of Vessel (Demarcated Within Red Lines)

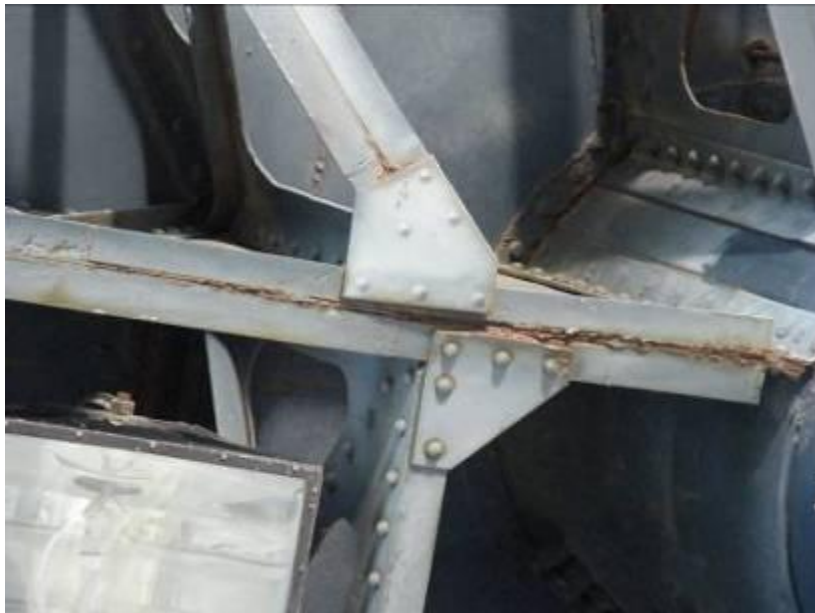
**Figure 12 Heavy Rust/Scale and Failing Rivets at Base of Structure**

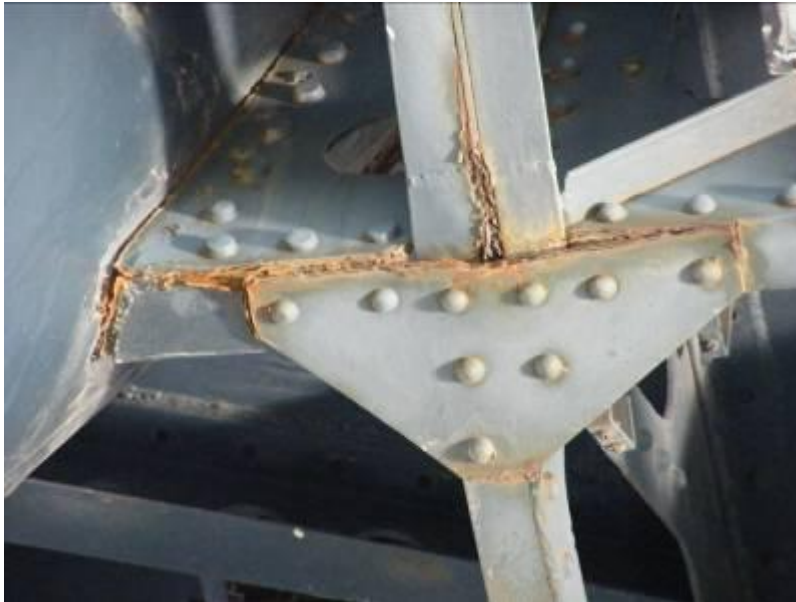
**Figure 13 Rust/Scale on Structure Supporting Forward Lookout Station**

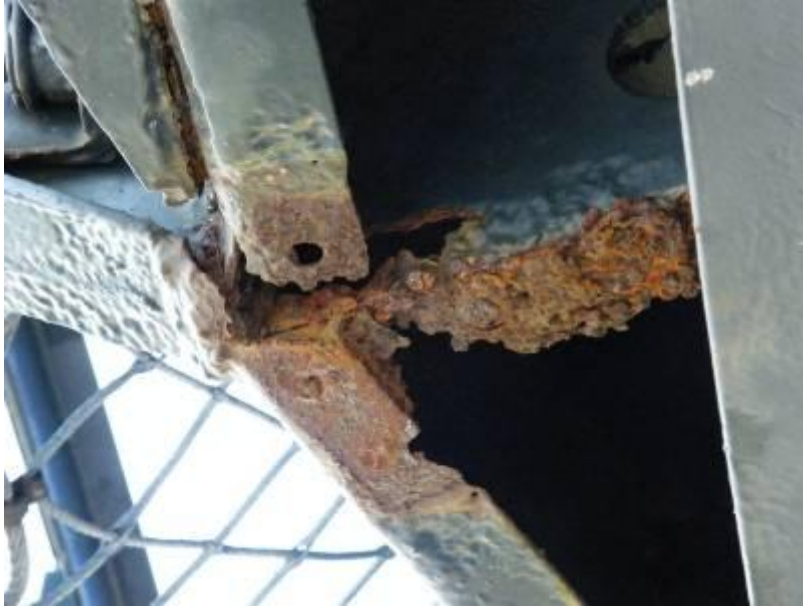
**Figure 15 Heavy Rust/Scale and Structure Failure on Base of Forward Lookout Station**

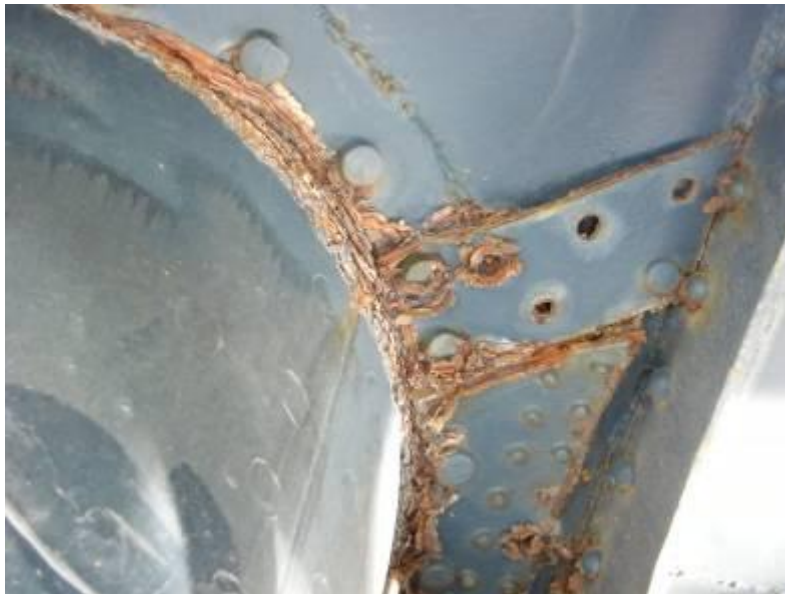
**Figure 16 Heavy Rust/Scale and Structural Failure on Base of Forward Lookout Station**

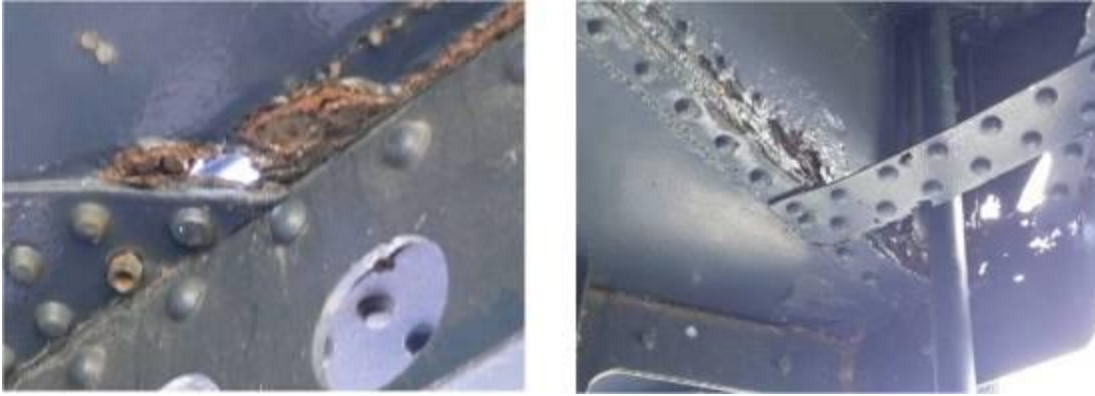
**Figure 21 Wasted Plating on Overhead, Deck and Support Structure of Navigation Bridge**

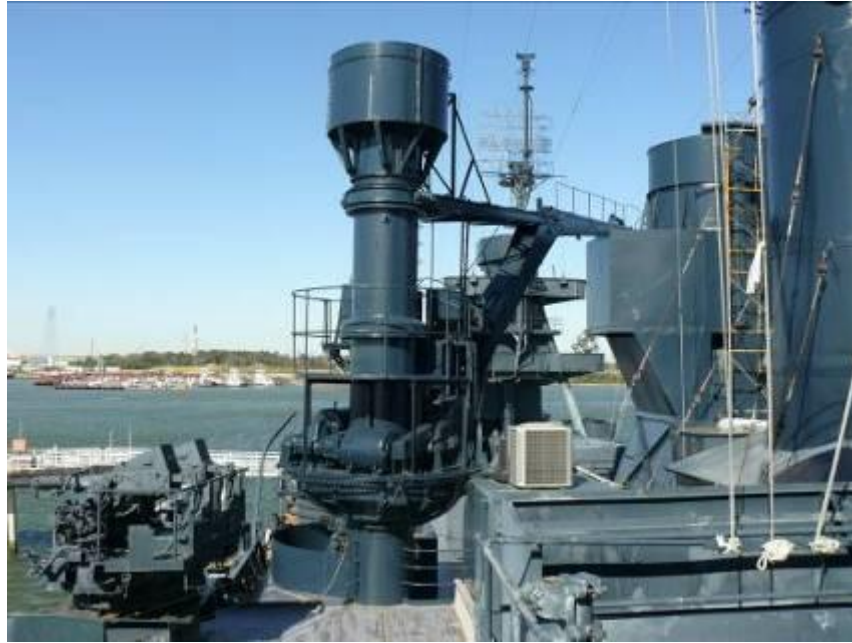
**Figure 28 Boat Crane (Starboard, Looking Aft)**

The boom is present, but the rigging and sheaves have been down-rigged (Figure 28). The crane base is in excellent structural condition and the foundation is in good repair. Degradation of tie rods and connecting bolts is apparent and requires repair. 20MM guns have been removed from top of crane. The structure is in good cosmetic condition. There is minor standing water and blocked drainage with resultant wastage of deck plating and crane base structure.

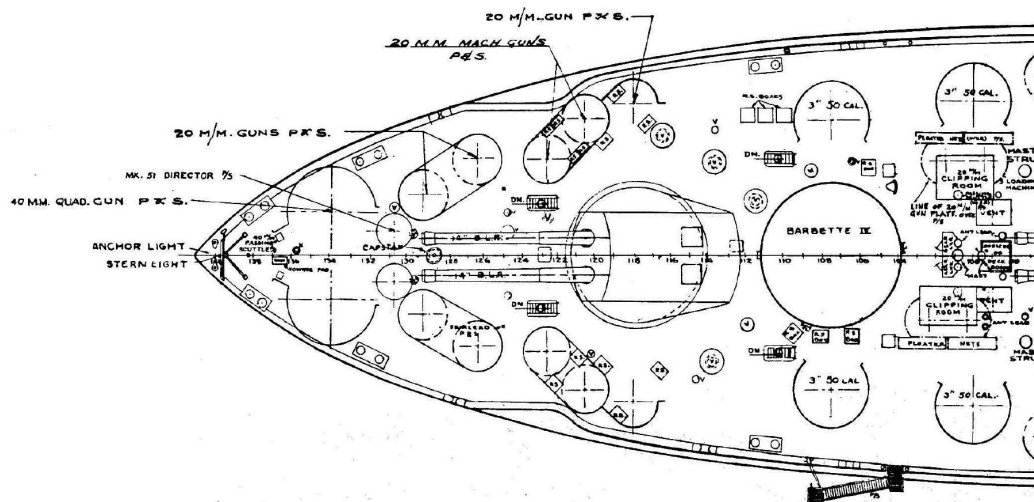
**Figure 57 Main Deck Layout form Main Mast to Stern**

This area of main deck (Figure 57) takes in the area aft of the mainmast to the stern. The deck is planked with what appears to be yellow pine/fir decking and is painted throughout. The main deck is very well marked with an easy flow for moving the visiting public to the various tour routes, both topsides and below.

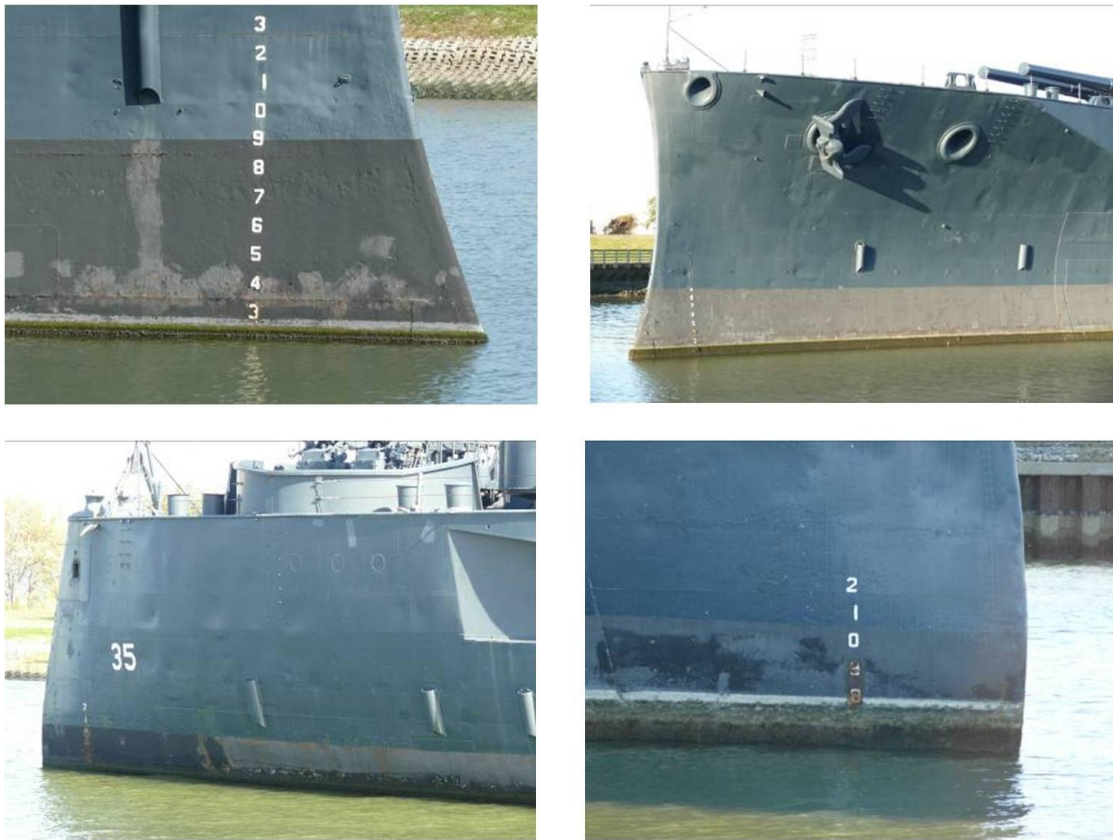
**Figure 65 Stem and Stern Hull Plating**

Observations of the hull plating before the blister tankage showed some patching to starboard and new plating fitted to port during the last shipyard progression. The condition of stem plating is good for the most part, except at the waterline. Observations of the hull plating aft of the blister tankage showed much patching to both starboard and port side plating as well as new plating fitted to port during the last shipyard progression. The condition of stern plating is poor over all areas, especially at the wind/waterline (Figure 65).

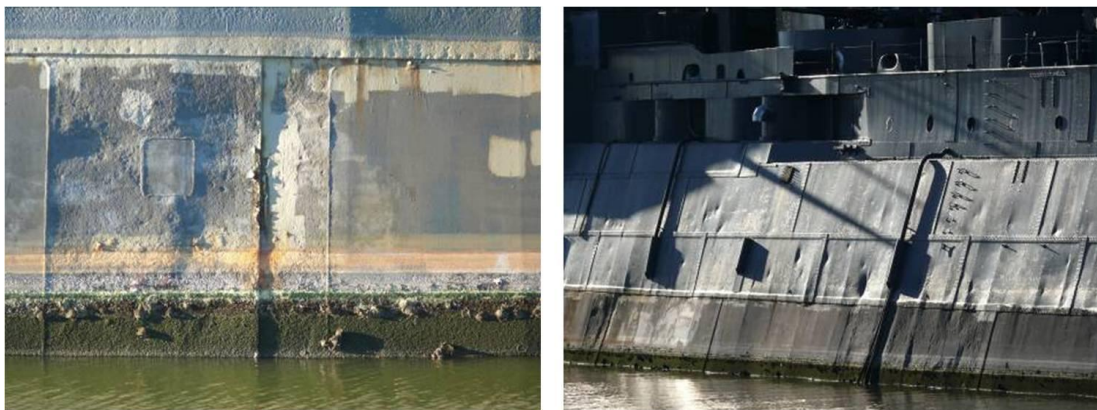
**Figure 66 Exterior of Blister Tankage**

The blister tankage shows graphic evidence of structural failure of interior scantlings and wasted plating. Tugs have previously heavily compressed surface plating (Figure 66). Other areas show no failure of the underlying frames & structural members. Oil canning is most prominent.

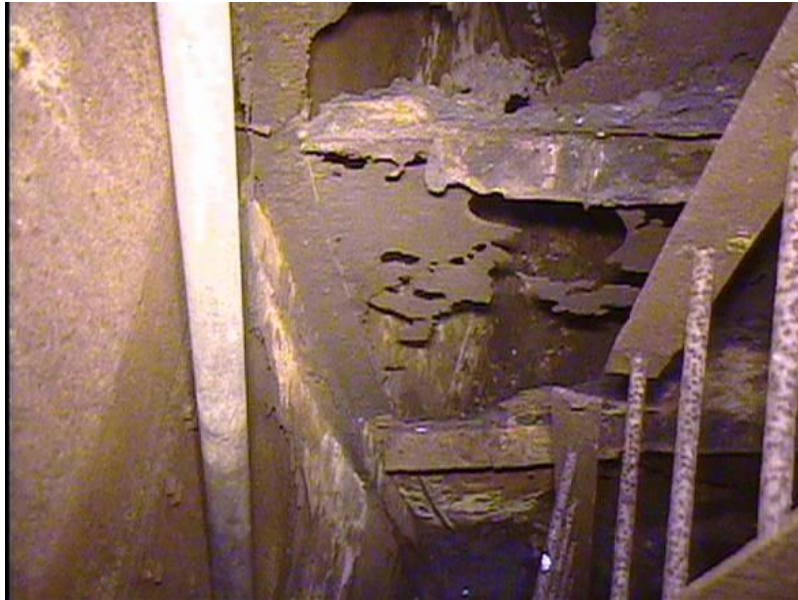
**Figure 67 Blister Tank Showing Broken Access Ladder and Wasted Transverse Web Frame (Armor Belt to Left)**

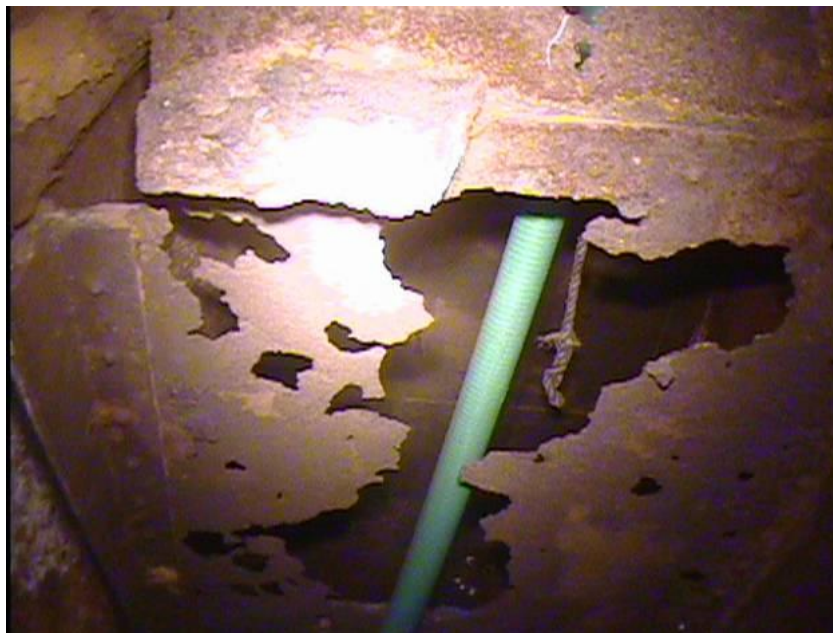
**Figure 68 Lower Transverse Bulkhead Within Blister Tank Showing “Swiss Cheese” Effect (Note Riveted Seam That Previously Had been Fastened to Armor Belt at Left)**

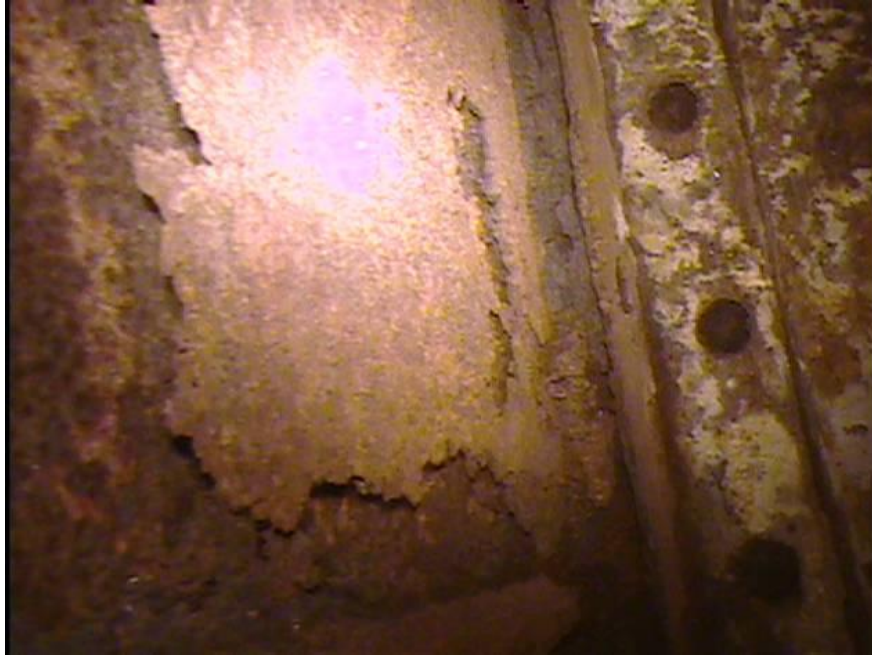
**Figure 69 Failed Riveted Seam and Heavy Scaling of Armor Within Blister Tank**

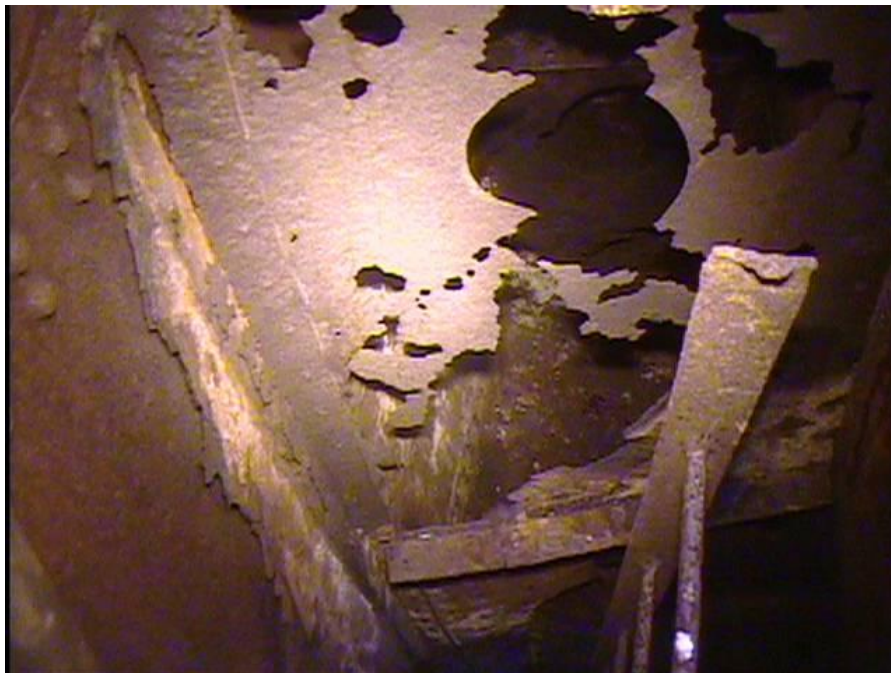
**Figure 70 Totally Failed Transverse Web Frame Within Blister Tank**

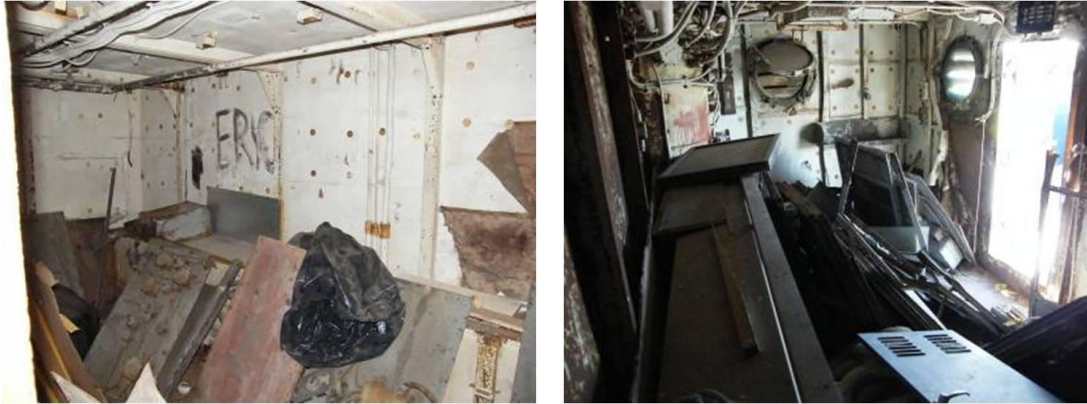
**Figure 77 Combat Information Center**

This space (Figure 77) is in a poor cosmetic condition and good structural condition and is largely used for storage.

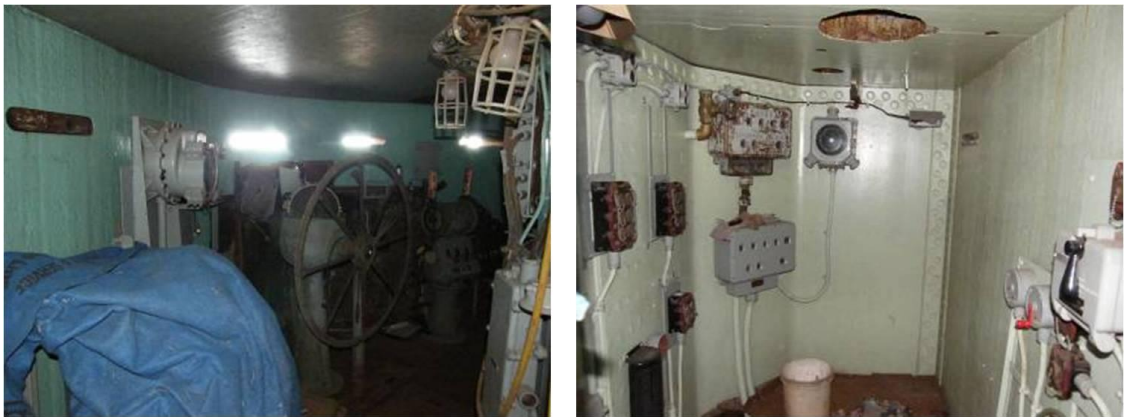
**Figure 78 Forward Armored Conning Station**

This space (Figure 78) is largely in excellent cosmetic and structural condition but suffers from worker debris and tools strewn about the space.

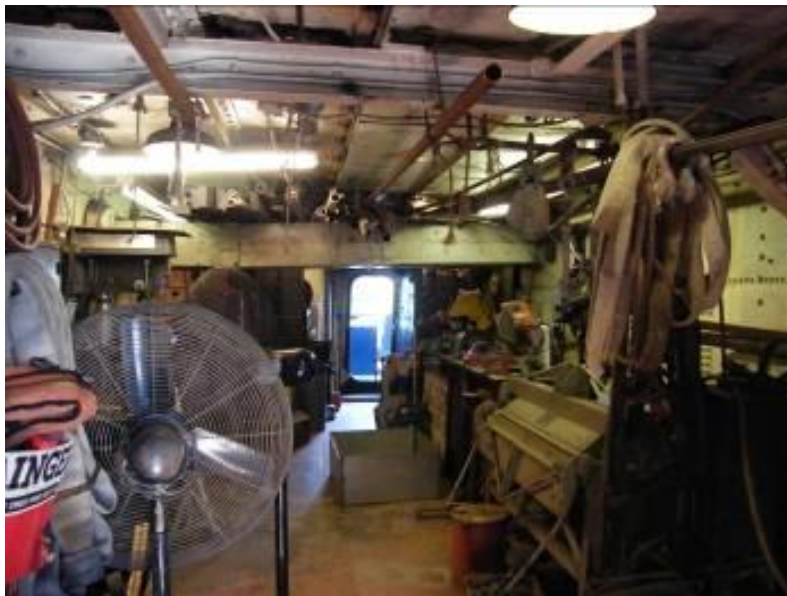
**Figure 89 Shipfitter Shop (Looking to Port)**

An athwartships space, this space (Figure 89) contains all manner of tools, work benches, power equipment and storage for the Maintenance Crew's gear. This space is in fair/good cosmetic and structural condition. The overhead under the air defense tower is rusted/scaled through and is in need of repair (Figure 90).

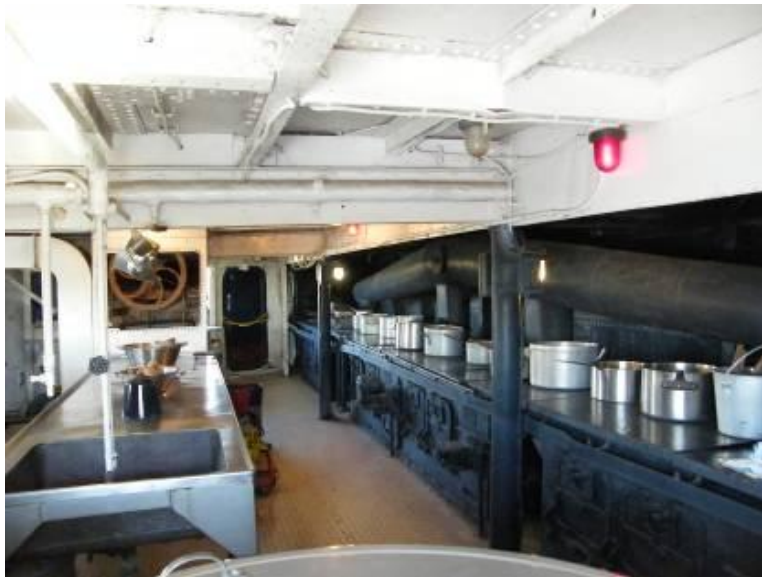
**Figure 91 Galley Space (Looking to Port)**

Open on main deck as an exhibit area, this space (Figure 91) suffers from rusted/scales/wasted steel decks underneath the concrete overlay.

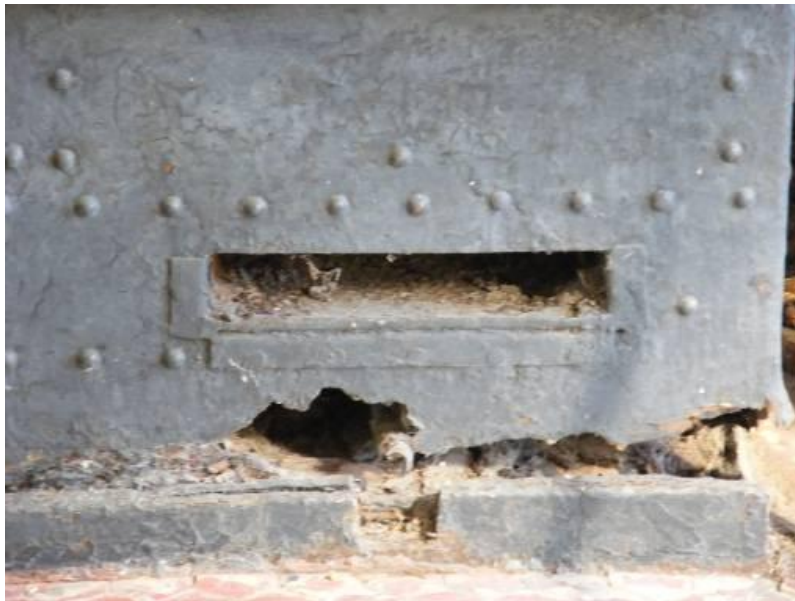
**Figure 93 Wasted Stove Vertical Surfaces (Endemic of Whole Space)**

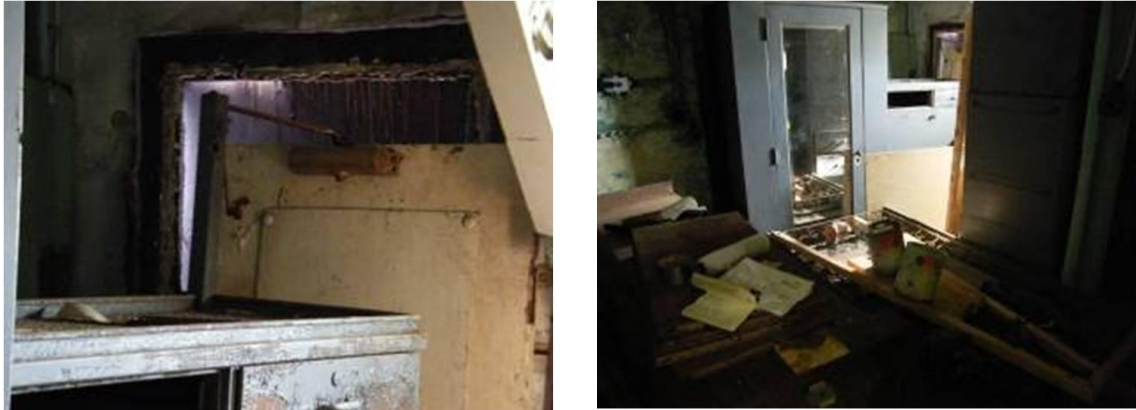
**Figure 106 XO Staterooms (Starboard)**

This space (Figure 106) is in good structural and poor cosmetic condition. There are large amounts of debris, workman's paint cans and discarded tools as well as much rust/scale throughout the space.

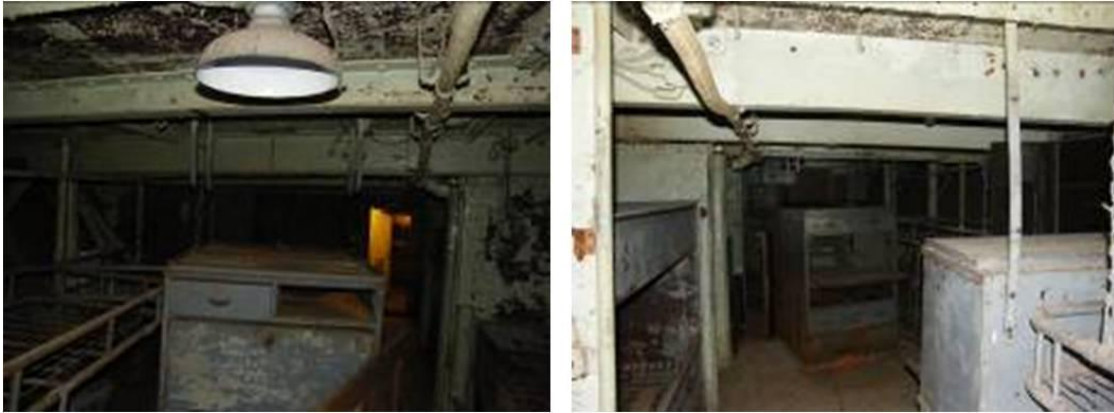
**Figure 187 Junior Officer Bunkroom (Starboard)**

This space (Figure 187) is in good structural and poor/fair cosmetic condition. Rust/scale abounds with a failed paint system.

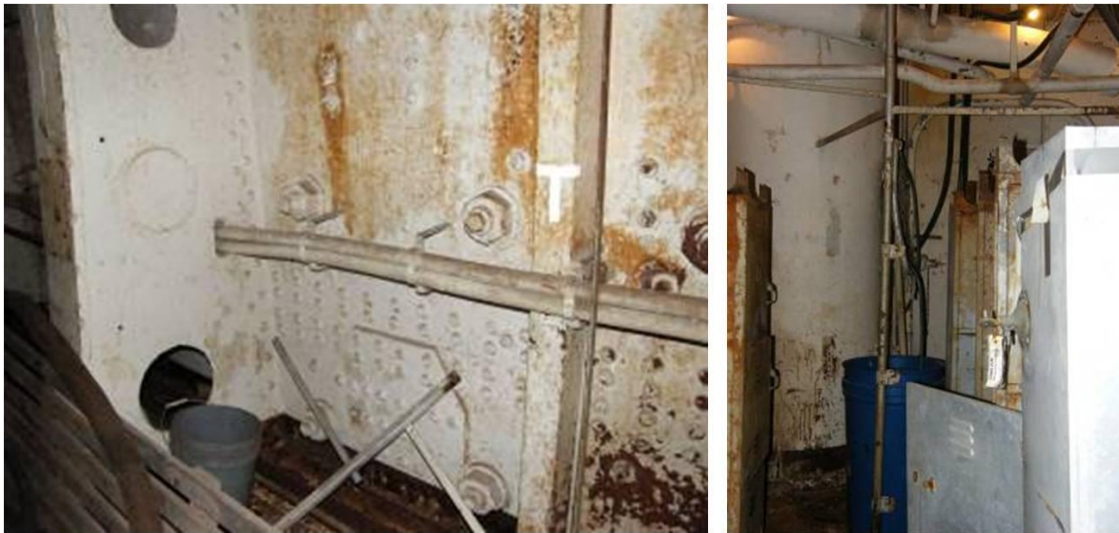
**Figure 217 Crew Space (B-106; Frames No. 58-66; Port)**

This space is in good structural and poor/fair cosmetic condition. Rust/scale abounds with a failed paint system.

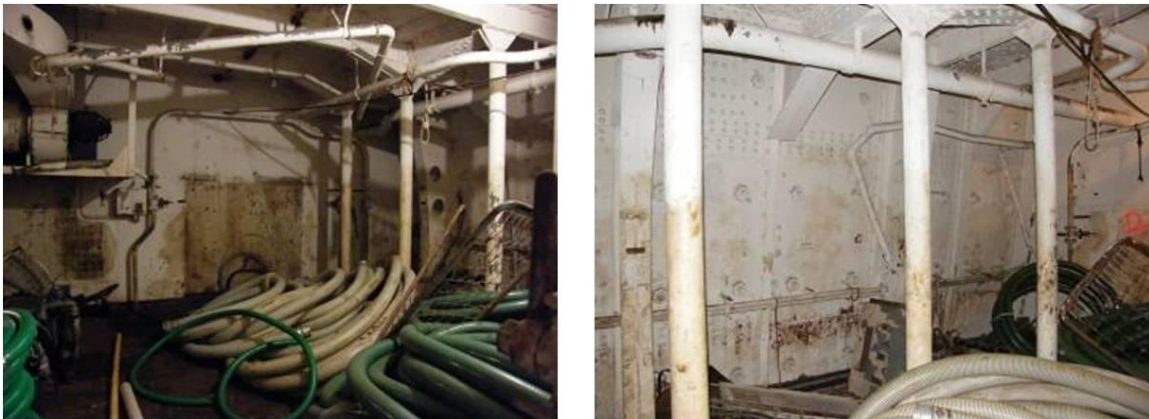
**Figure 218 Crew Space (B-110; Frames No. 66 – 71; Port)**

This space is in good structural and poor/fair cosmetic condition. Rust/scale abounds with a failed paint system.

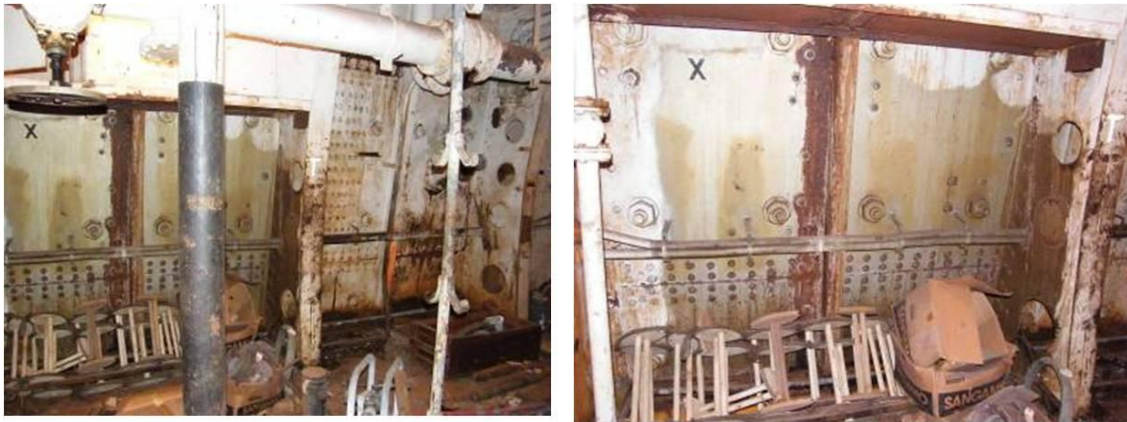
**Figure 219 Crew Space (B-112; Frames No. 71 – 76; Port)**

This space is in good structural and poor/fair cosmetic condition. Rust/scale abounds with a failed paint system.

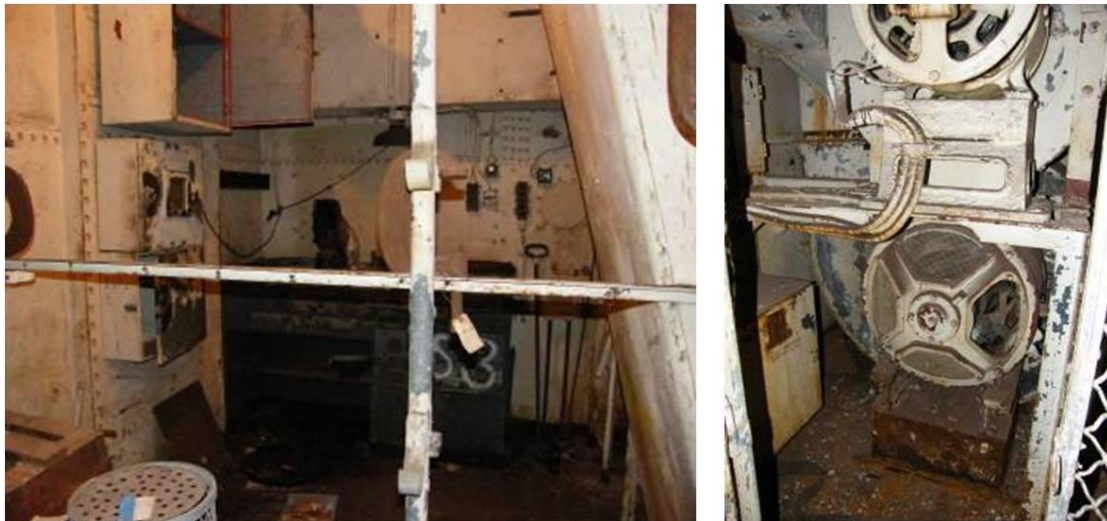
**Figure 220 Blower Room (Port)**

This space is in good structural and poor/fair cosmetic condition. Rust/scale abounds with a failed paint system.

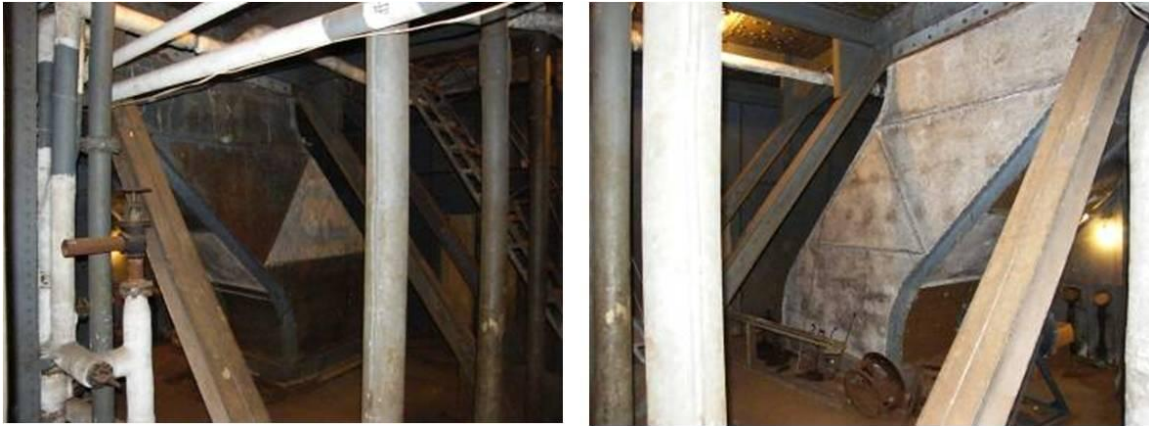
Figure 233 Drying Room (B-3, Frames No. 62 – 68 ½; Centerline)

This space is in good structural and poor/fair cosmetic condition. The deck is holed in several areas.

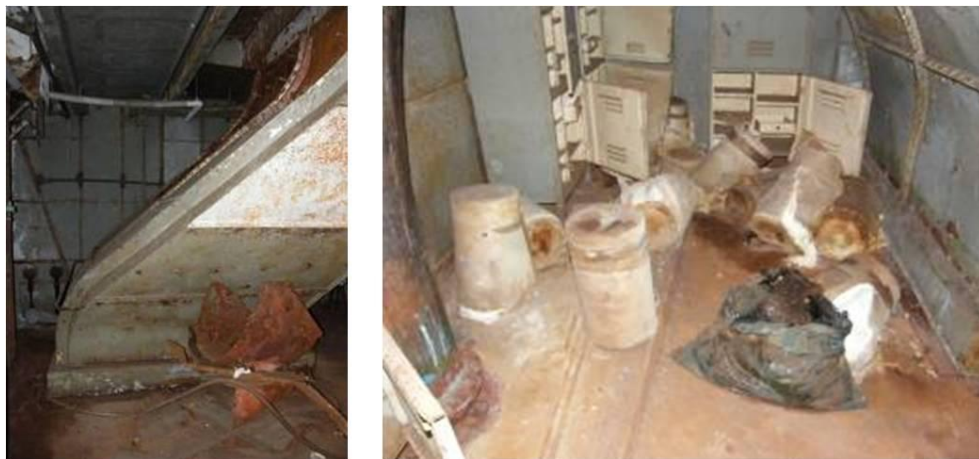
Figure 234 Drying Room (B-4, Frames No. 68 ½ - 76; Centerline)

This space is in good structural and poor/fair cosmetic condition. The deck is holed in several areas.

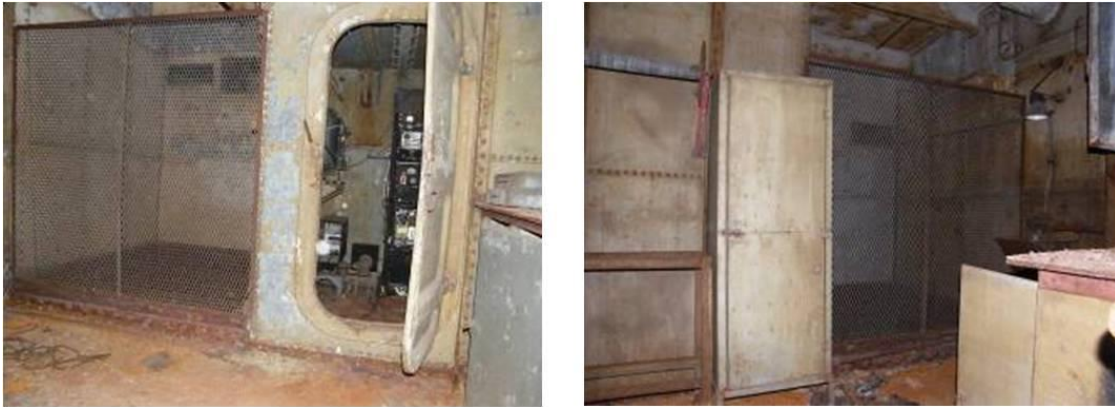
**Figure 235 Oil King Shack (left panel) and Boiler Marker Room (Right Panel)**

These spaces are in fair/good structural and poor/fair cosmetic condition. The deck is holed in several areas.

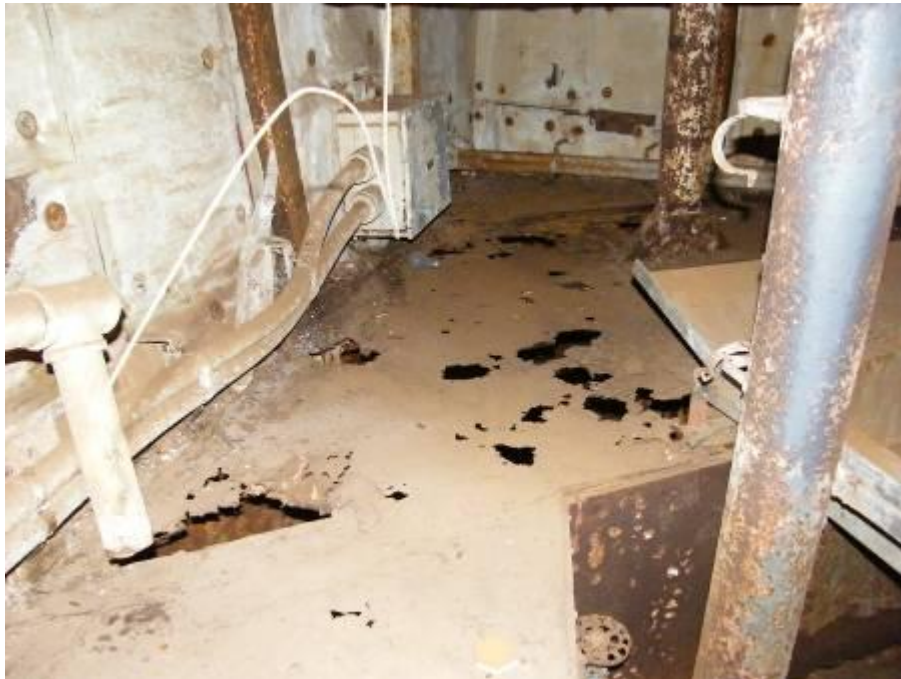
The deck is paper thin (or failed outright) throughout and needs to be replaced as a safety and structural issue. The hatches leading to the pair of voids below have wasted frames/foundations and need to be replaced.

**Figure 254 Wasted Tank Tops in CPO Pantry**

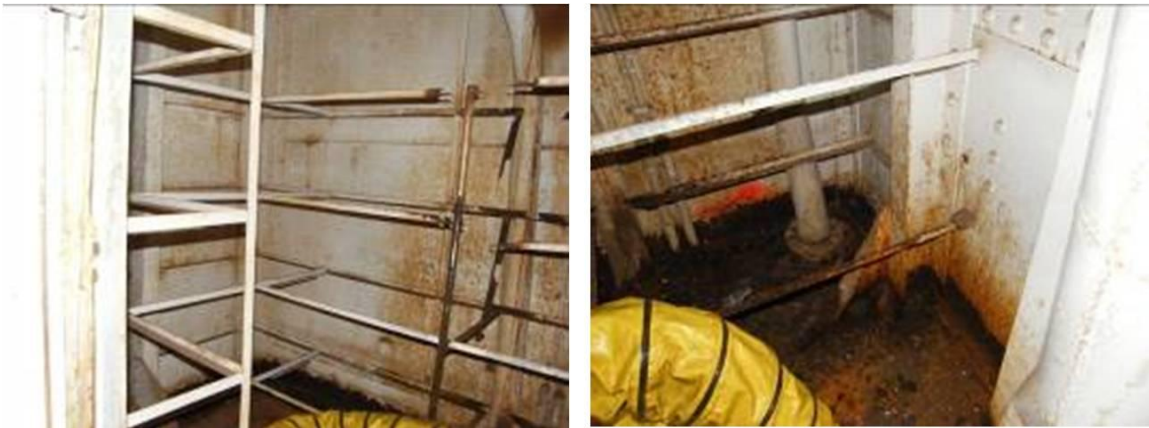
Figure 293 Storerooms (D-37) Port (Left Panel) and Starboard (Right Panel)

These spaces are in poor structural and fair cosmetic condition. Entire deck is holed and badly corroded.

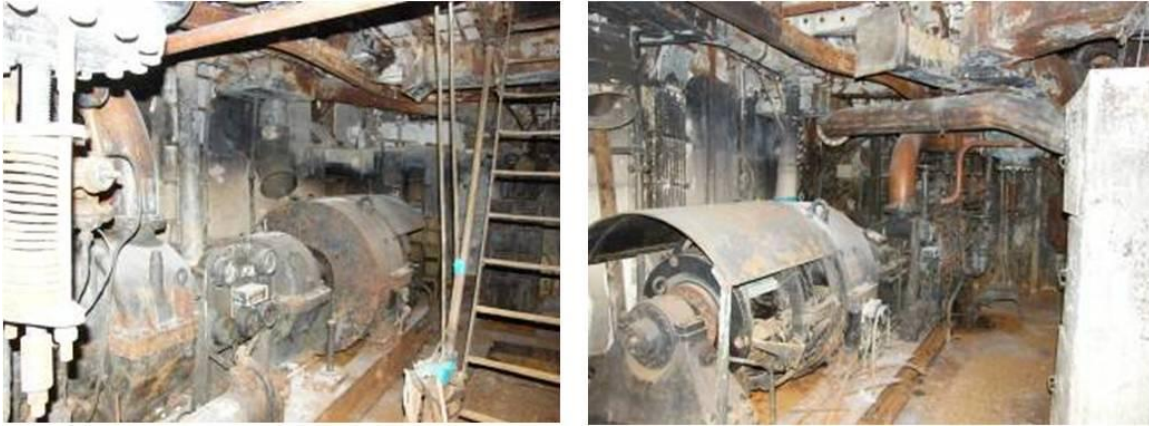
**Figure 319 Aft Dynamo Room (C-24, Frames No. 77 ½ - 84 ½)**

This space is in fair structural and poor cosmetic condition. The deck is weak in many areas and needs to be repaired. Poor air quality within this and lower spaces should be improved with adequate ventilation. Lighting is poor or non-existent.

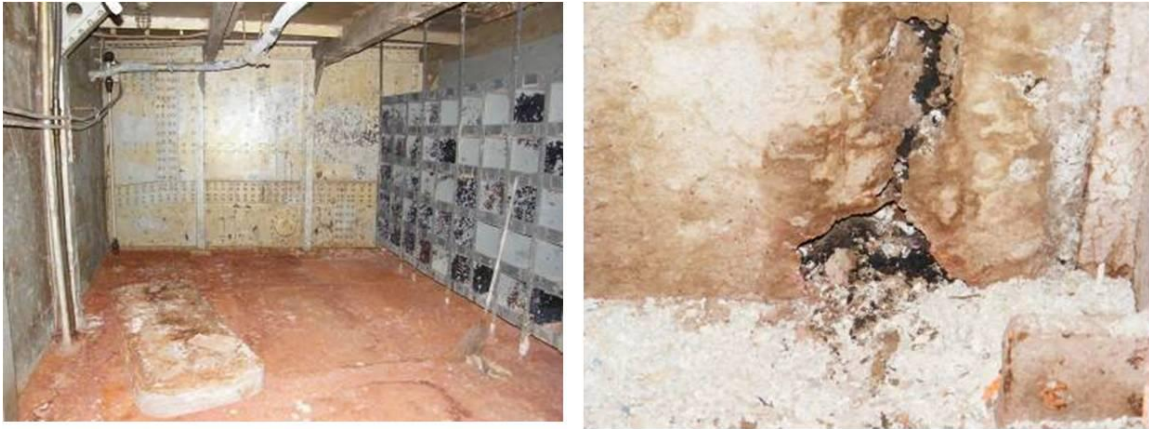
cracked where it meets the deck.

**Figure 324 Main Stores (D-17S; Starboard) Showing Heavily Wasted and Cracked Bulkhead Where it Meets Deck (Right Panel)**

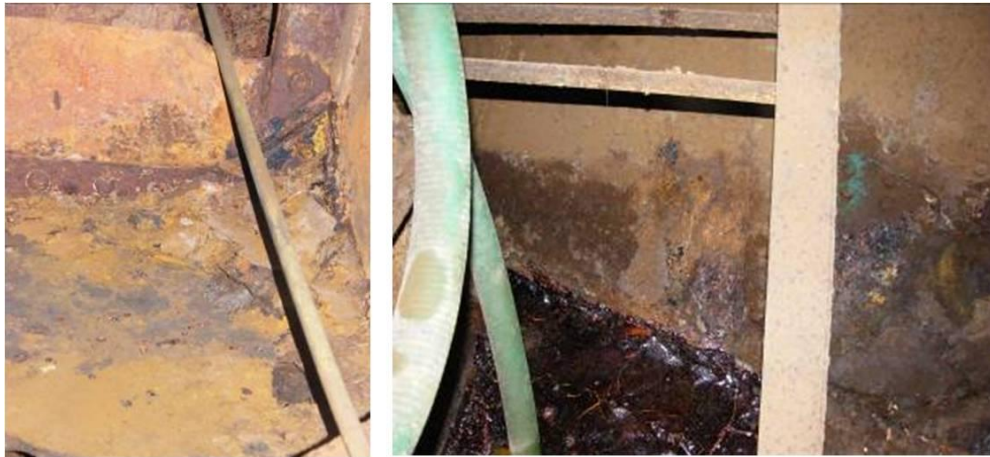
This space is in poor structural and poor cosmetic condition. The main web frames are badly wasted; likewise the fore and aft bulkhead are non-watertight with standing oil and water on deck. This space has had leaking plating in the past and is cause for concern given that there is wetness observed in bilge pockets.

**Figure 328 Wasted Floor (Left Panel) and Standing Water in Bilge Pockets (Right Panel) in Sanitary Pump Room (D-20-P; Port)**

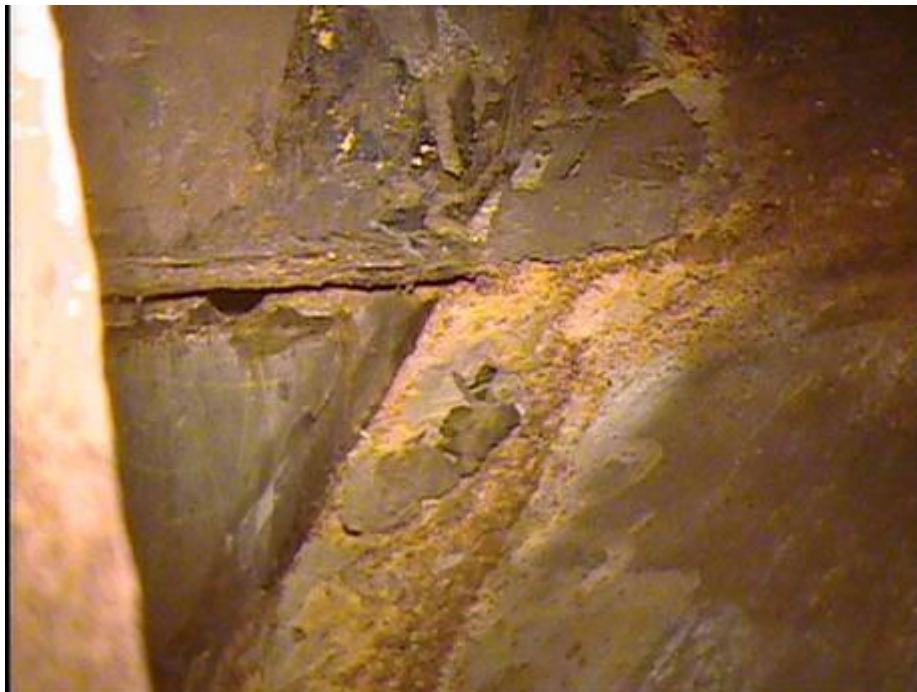
**Figure 394 Wasted Shell Plating and Forward Bulkhead Where Major Leak Occurred During the Week of Inspection (Trimming Tank Void D-12V)**

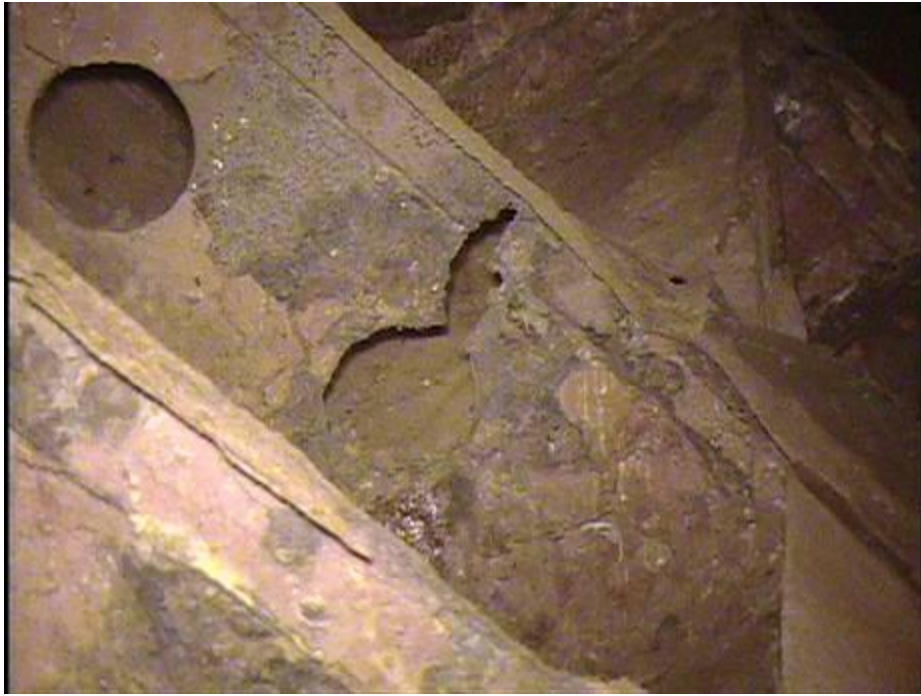
**Figure 395 Wasted Main Transverse Frame in Lower Area of Trim Tank Showing Wasted Longitudinal Stringer at Right Lower Side of Photo (Trimming Tank Void D-12V)**

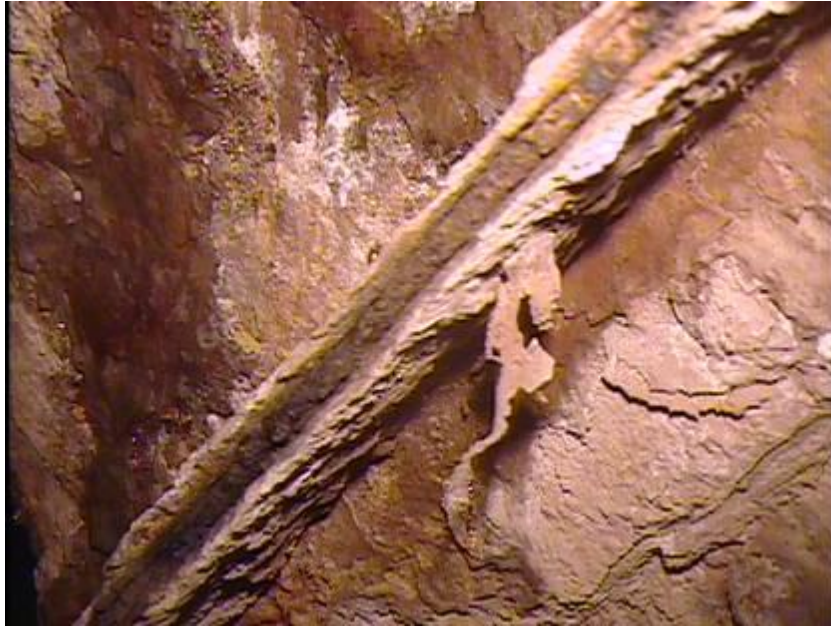
**Figure 400 Typical Detail of Wastage of Main Transverse Web Frame (Trimming Tank Void D-13V)**

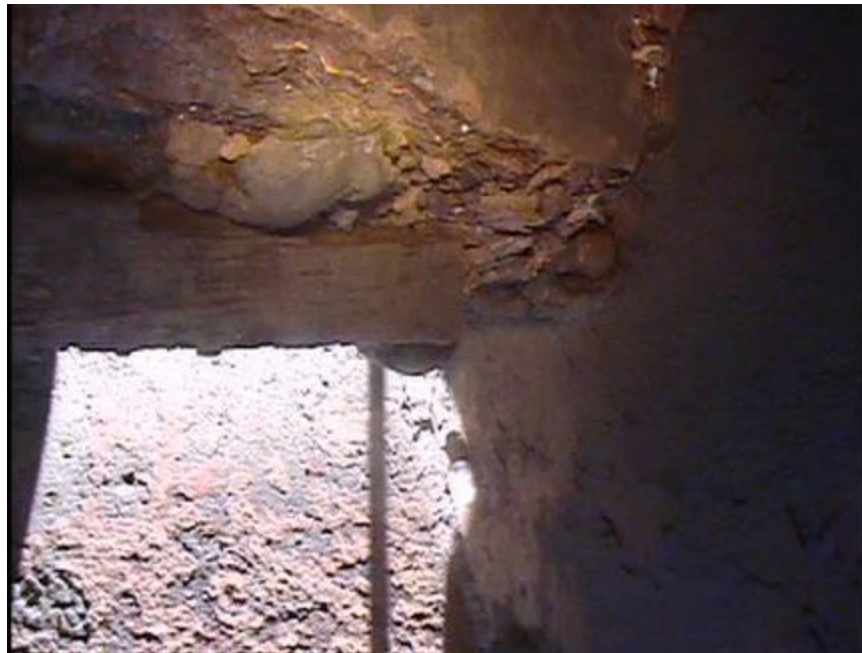
**Figure 401 Cut-away on Keel Showing Wasted Condition of Shell Plating (Trimming Tank Void D-13V)**
